DEPARTMENT OF TRANSPORTATION**DIVISION OF ENGINEERING SERVICES**

Contract #: 04-0120F4Cty: SF/Ala Rte: 80 PM: 13.2/13.9File #: 69.28**WELDING INSPECTION REPORT****Resident Engineer:** Siegenthaler, Peter**Address:** 333 Burma Road**City:** Oakland, CA 94607**Report No:** WIR-016763**Date Inspected:** 06-Sep-2010**Project Name:** SAS Superstructure**OSM Arrival Time:** 1900**Prime Contractor:** American Bridge/Fluor Enterprises, a JV**OSM Departure Time:** 700**Contractor:** Zhenhua Port Machinery Company, Ltd (ZPMC), Changxing Island **Location:** Shanghai, China**CWI Name:** See below**CWI Present:** Yes No**Inspected CWI report:** Yes No N/A**Rod Oven in Use:** Yes No N/A**Electrode to specification:** Yes No N/A**Weld Procedures Followed:** Yes No N/A**Qualified Welders:** Yes No N/A**Verified Joint Fit-up:** Yes No N/A**Approved Drawings:** Yes No N/A**Approved WPS:** Yes No N/A**Delayed / Cancelled:** Yes No N/A**Bridge No:** 34-0006**Component:** Tower and OBG Components**Summary of Items Observed:**

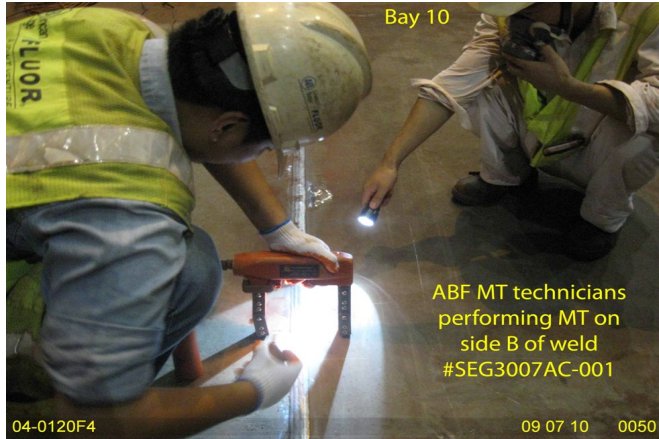
SAW welding of weld joint SEG3007AC-001, side B located on PCMK OBG segment 13AE. Tandom welders were identified as 044771, 044750. QC was identified as QC1. Assisting QC1 at this location and appearing to be monitoring the welding and recording data was ZPMC QC Zhang Lin (QCA2), who was not a CWI. Welding variables recorded by QCA2 appeared to comply with WPS-B-T-2221-B-U3c-S-2. The weld was being kept at or above the minimum preheat and interpass temperature with electric heaters placed above and below the plates at the weld. Also at this location and appearing to be monitoring the welding operation was ABF Representative Wei Jian Bo. When ABF Representative Kelvin Cheung notified this QA Inspector that this weld was finished, this QA Inspector observed ABF MT (magnetic particle testing) technicians perform 100% MT, then this QA Inspector performed random VT (visual testing) and MT on the weld before the plate was rotated to side A facing up. See photo below. ABF MT technicians and this QA Inspector concurred that no apparent indications were observed.
